March 31, 2009

Re: OU2 Riverbank Soil Sampling and Pipe Abandonment
Swan Island Upland Facility
Portland, Oregon
ECSI No. 271
1115

OU2 Soil Sampling and Pipe Abandonment
Swan Island Upland Facility
Portland, Oregon

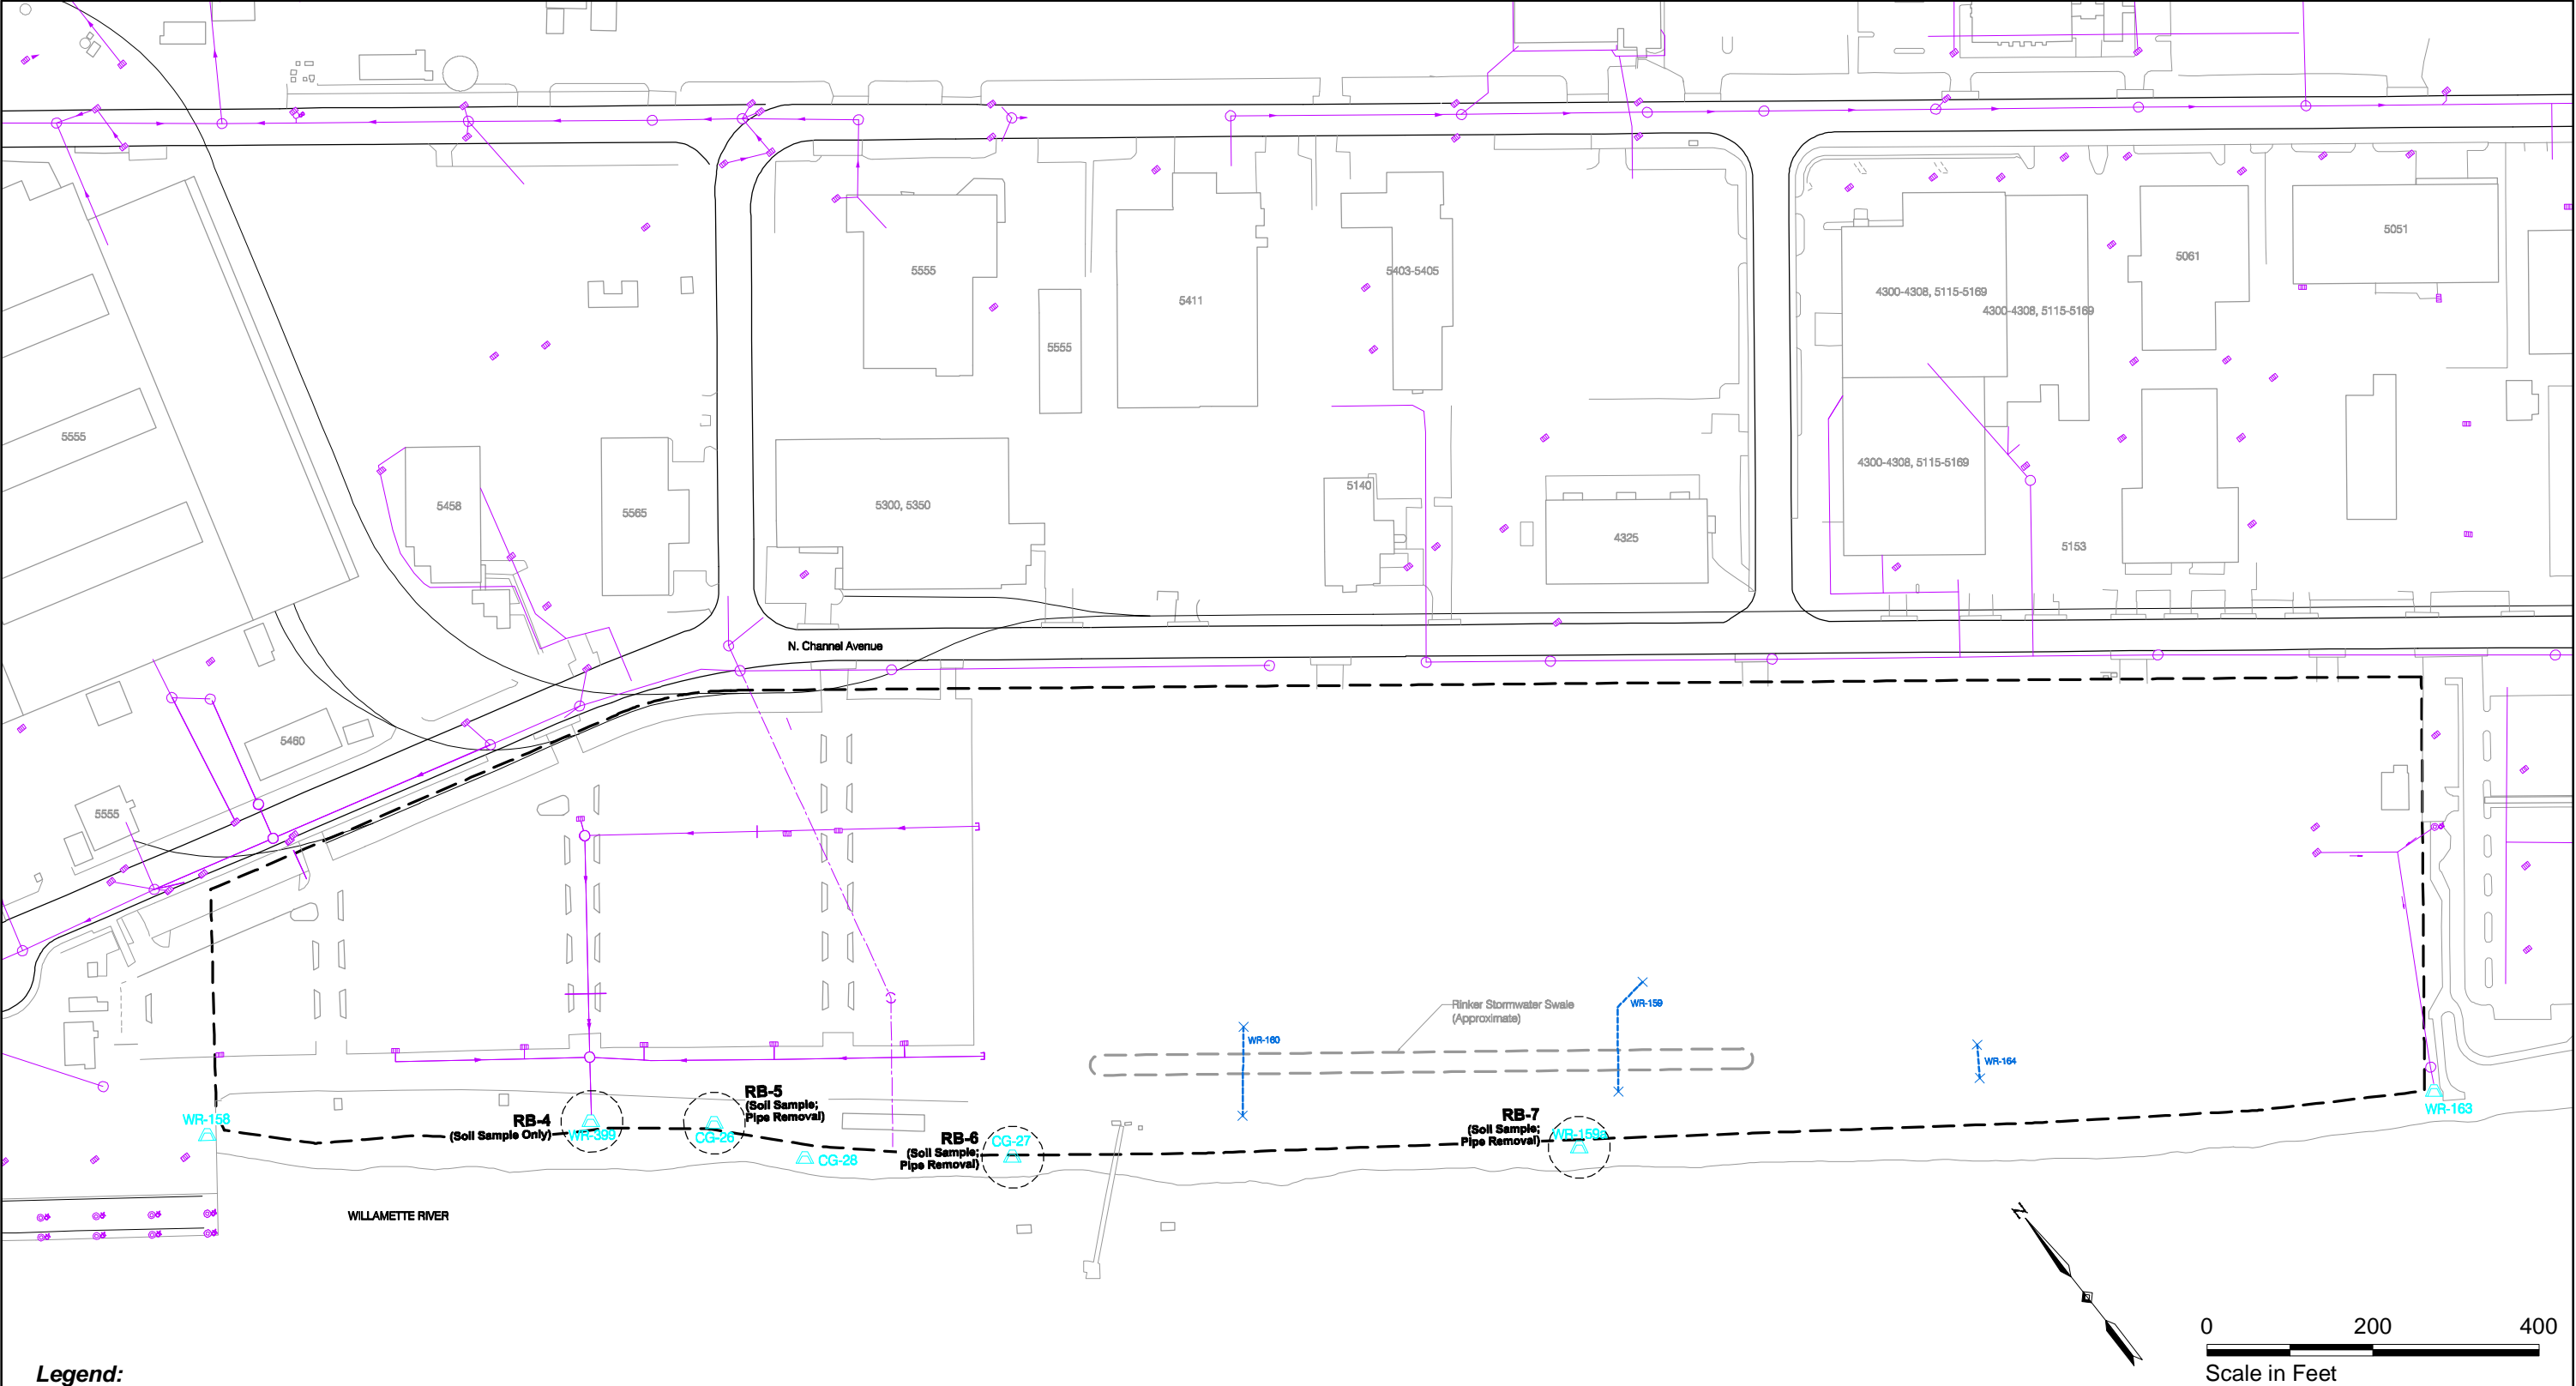
Figure 3

Sampling and Pipe Removal Plan

ACA collected riverbank soil samples at outfall WR-399 and inactive outfall pipes CG-26, CG-27, and WR-159a (Figure 3) on October 1, 2008. The invert elevation of WR-163 is below the OLHW and will be evaluated in the SCE for OU2. Three soil samples were collected from the riverbank below each outfall consistent with the approach previously used at the three pipes that were removed by the Port in 2006 (i.e., outfalls WR-159, -160 and -164). The samples were collected in accordance with Standard Operating Procedures (SOPs) -2.1 and -2.2 (Attachment B). The samples were labeled "a", "b", and "c". The "a" sample was collected near the top of the riverbank just below the end of the outfall. The "c" sample was collected at an elevation corresponding to OLLW, or approximately 1 to 2 feet above the river, whichever was higher. The "b" sample was collected approximately halfway down the riverbank between the "a" and "c" samples.

Terra Hydr, Inc. abandoned the pipes at inactive outfall pipes WR-159a, CG-26, and CG-27 on October 2, 2008 (under subcontract to ACA) per the following procedure (with photographs showing a typical location):

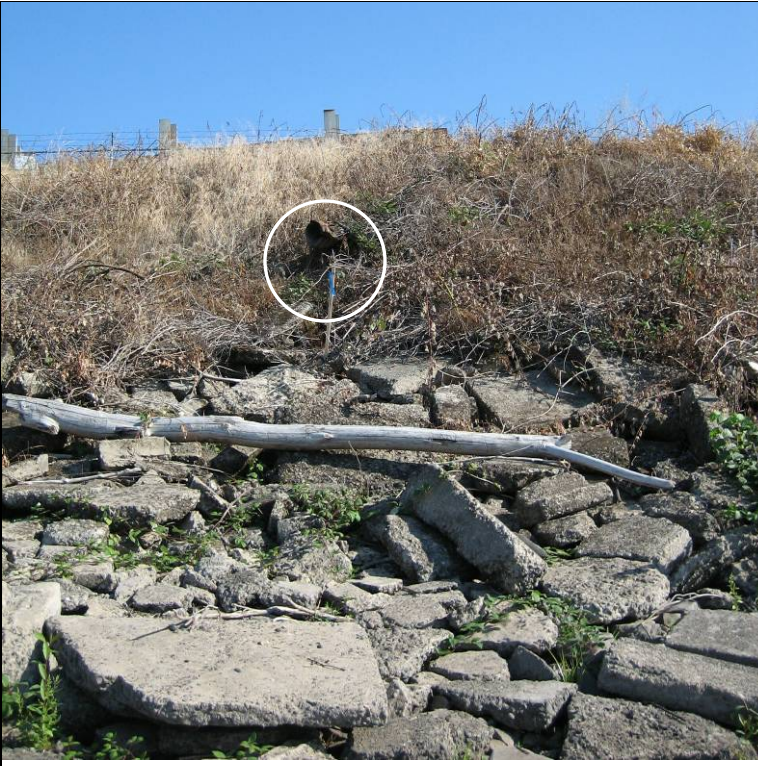
Photo No: 1

A photograph of a rocky, sloping terrain under a clear blue sky. The foreground is covered with large, flat, grey rocks and some sparse green vegetation. A long, light-colored log lies horizontally across the middle ground. In the background, there is a hillside covered in dry, yellowish-brown grass and some small trees. A white circle is drawn around a dark, vertical object (the outfall pipe) on the hillside.
Photo Date: 9/29/08	
Orientation: Northeast	
Description: Outfall CG-26 (circled) with OLHW stake at sampling location RB-5a.	
Photo No: 2

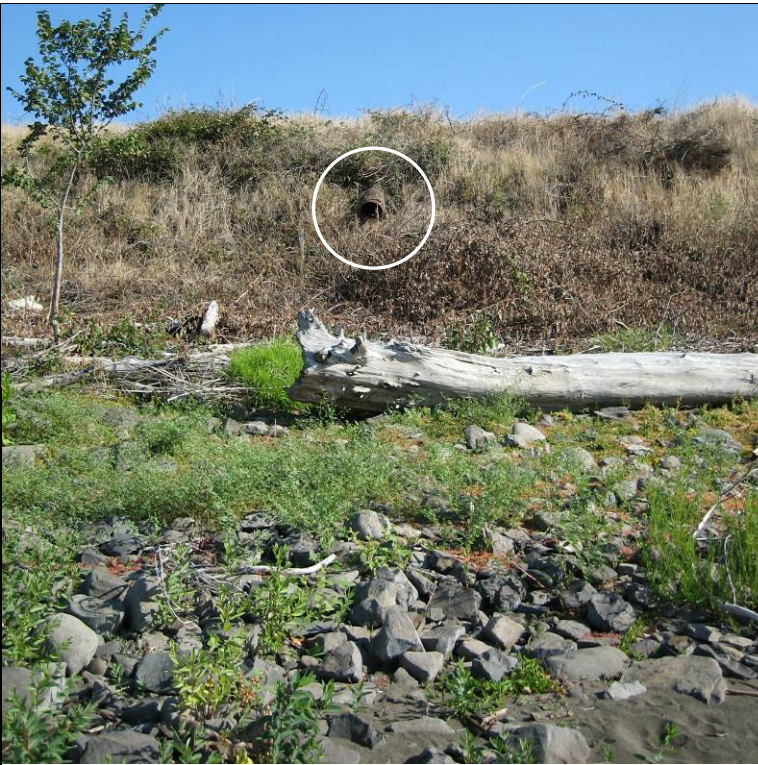
Photo Date: 9/29/08	
Orientation: Northeast	
Description: Outfall CG-27 (circled) with OLHW stake at sampling location RB-6a.

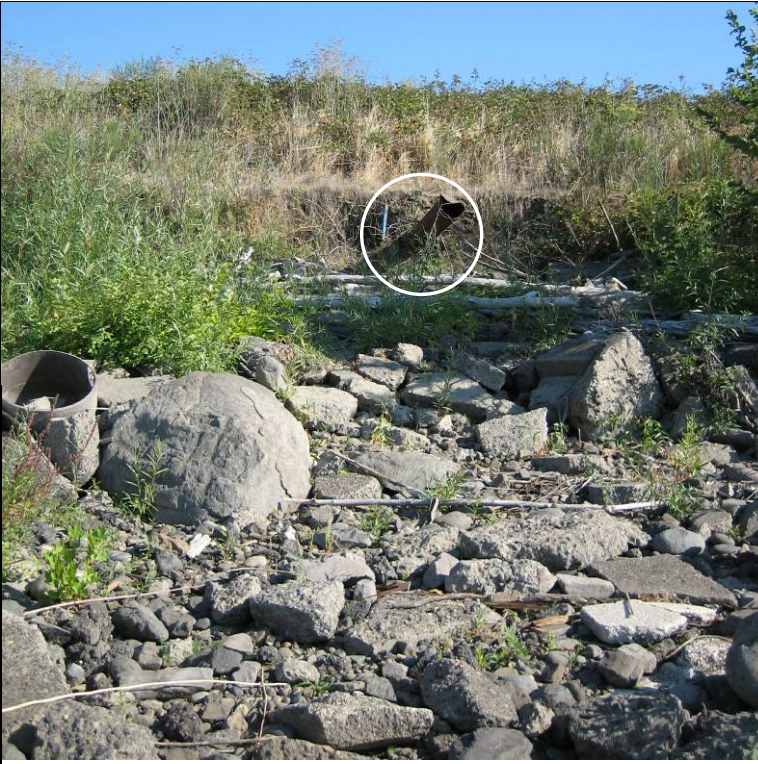
Photo No: 3

Photo Date: 9/29/08	
Orientation: Northeast	
Description: Outfall WR-159a (circled) with OLHW stake at sampling location RB-7a.

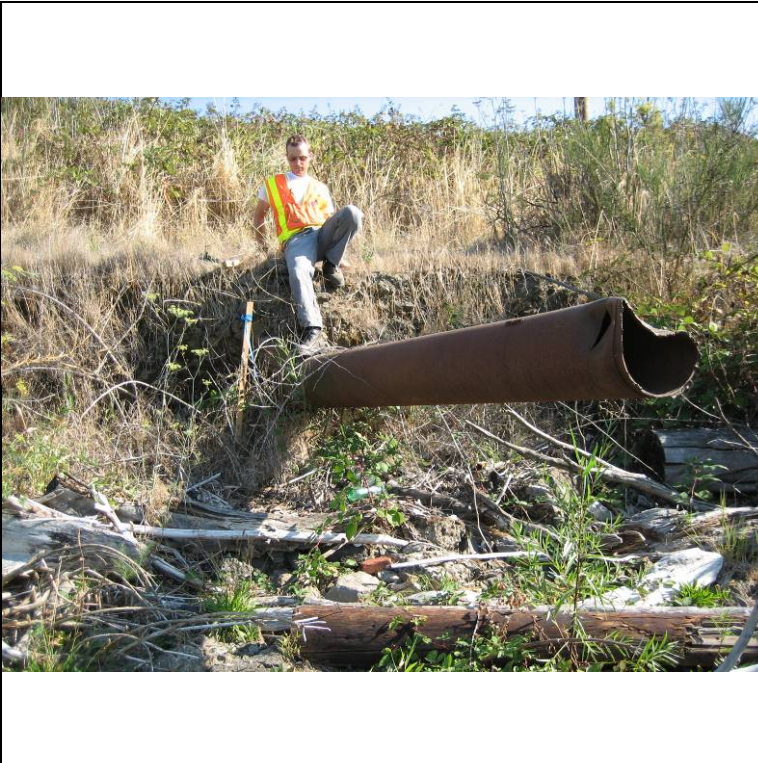
Photo No: 4

Photo Date: 9/29/08	
Orientation: Northeast	
Description: Outfall WR-159a with close-up of OLHW stake.

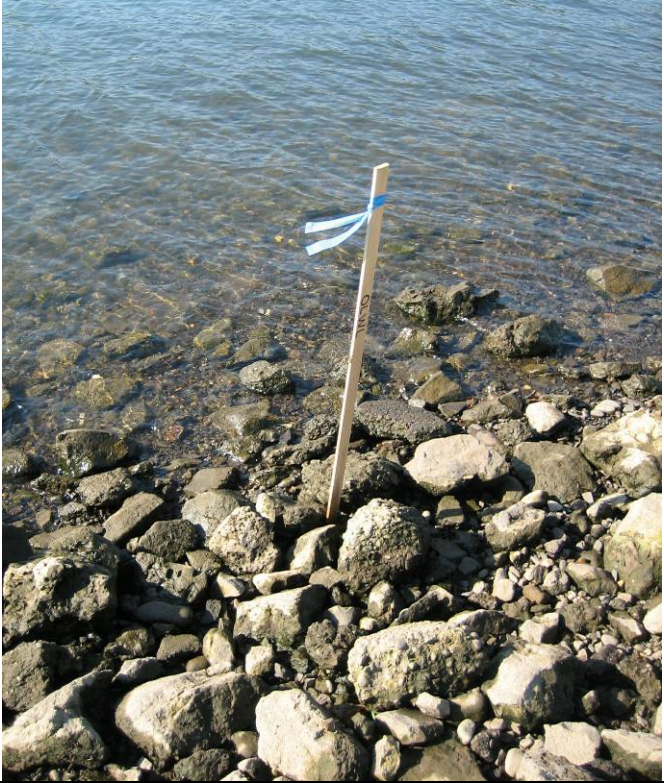
Photo No: 5

Photo Date: 9/29/08	
Orientation: Southwest	
Description: OLLW stake at sampling location RB-7c.	
Photo No: 6

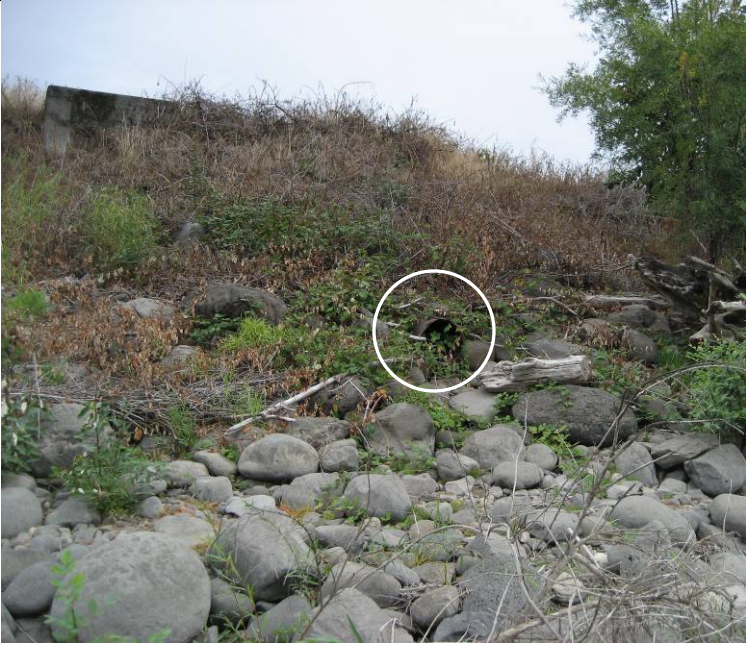
Photo Date: 10/2/08	
Orientation: Northeast	
Description: Pipe CG-28 identified during the Port utility locate.

An additional pipe located below the OLHW was identified during the Port utility locate (Figure 3; Photograph 6). The pipe was designated CG-28. The outfall is an inactive, 24-inch corrugated pipe.

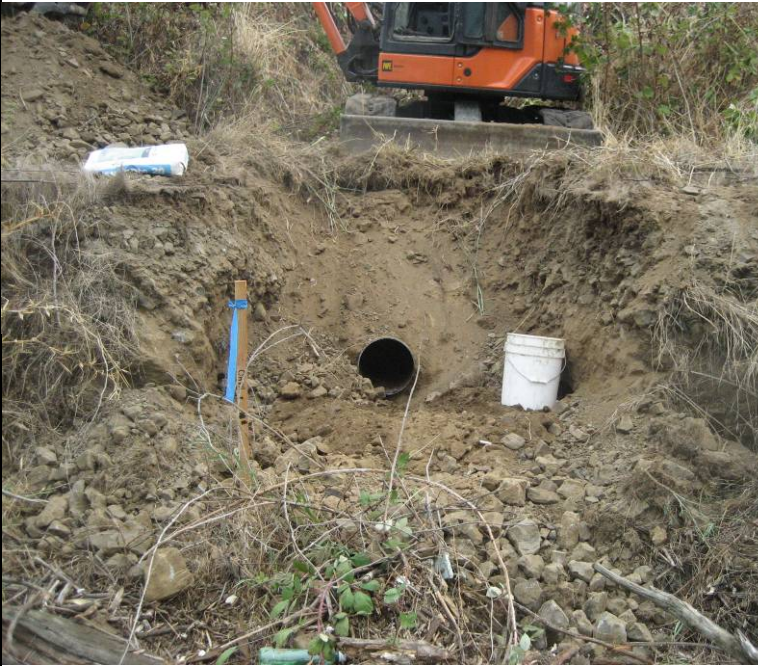
Photo No: 7

Photo Date: 10/2/08	
Orientation: Northeast	
Description: Outfall WR-159a after excavation and pipe removal.	
Photo No: 8

- Excavate the bank around outfall exposing approximately 5 feet of pipe (Photograph 7);
- Cut off pipe using oxygen-acetylene cutting torch;
- Plug pipe with non-shrinking cement grout (Photograph 8); and
- Backfill the excavation with native material (Photograph 9).

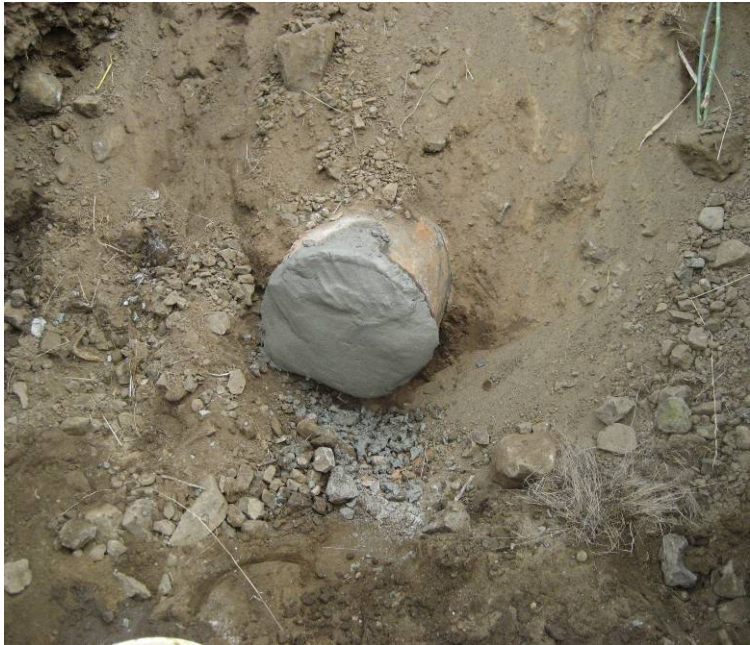
Photo Date: 10/2/08	
Orientation: North	
Description: Outfall WR-159a after plugging with non-shrink cement.

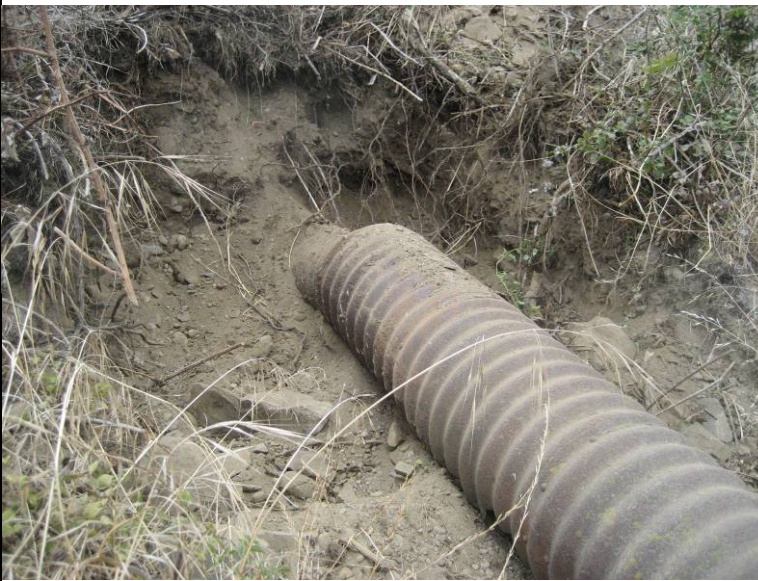
Photo No: 10

Photo Date: 10/2/08	
Orientation: Northeast	
Description: Outfall CG-26 after excavation. The excavation revealed that the pipe reduced from 18-inch to 12-inch corrugated approximately 5 feet into the bank.

- Inactive Outfall Pipe CG-26. Accessed via Cascade General/Vigor service road. The excavation revealed that the pipe reduced from 18-inch to 12-inch corrugated approximately 5 feet into the bank (Photograph 10). The pipe was cut and plugged.
